## Bonaspecta Holsteins

1133 Jersey Street South

Inspection: 9-1-17

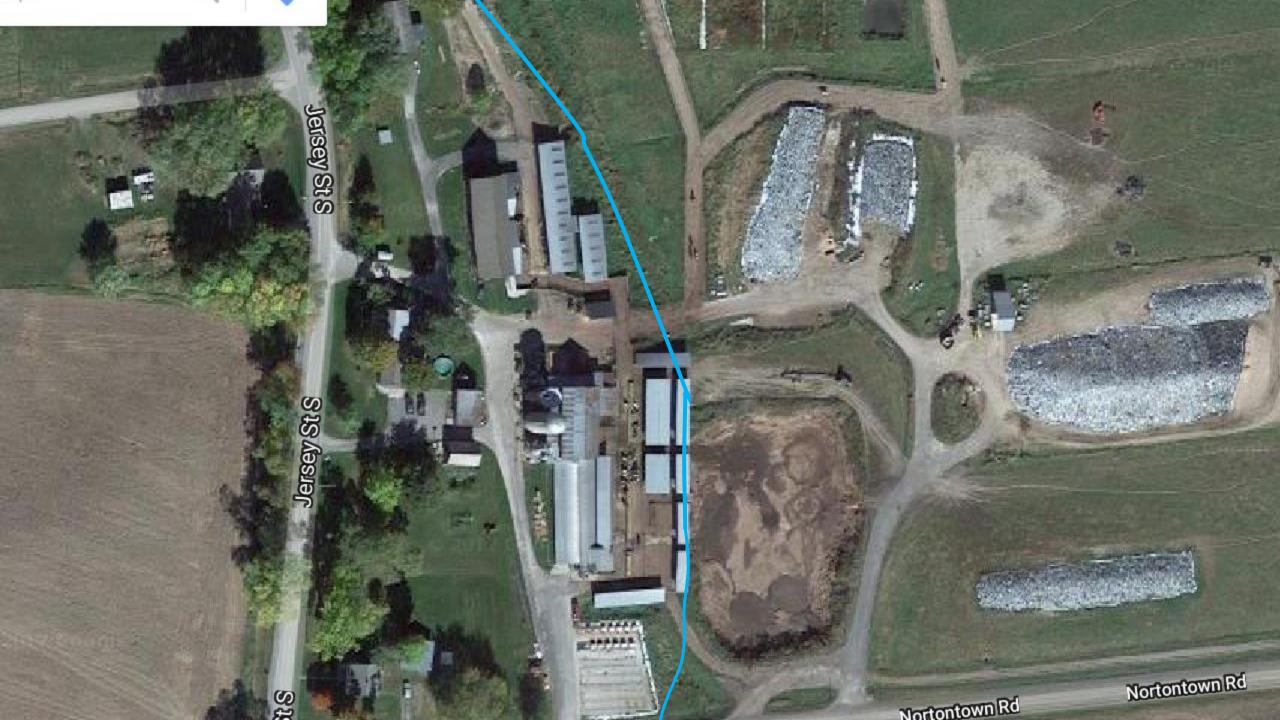
At the south end of the farm, the calves are kept in small hutches on a gravel pad. The photograph on right was taken from the north end of the calf pad. (See photographer icon and directional arrow.)

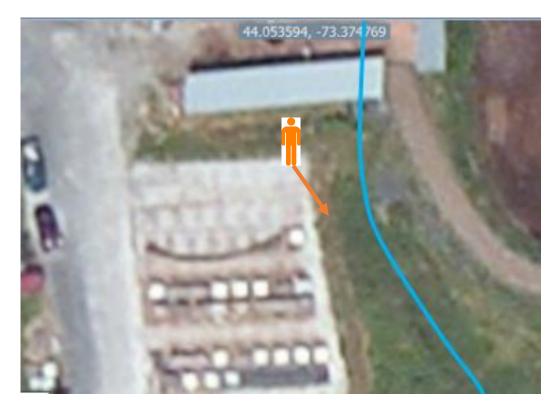
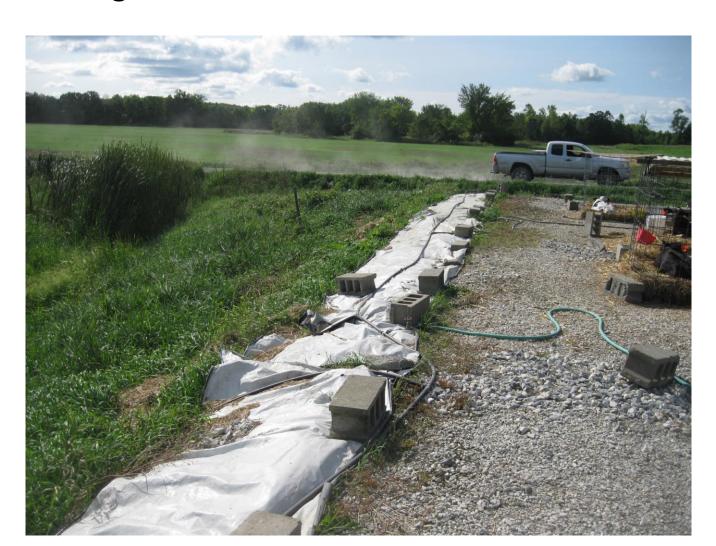
Bonaspecta Holsteins Addison, VT 9-1-17

According to the USGS map, an unnamed stream appears to run above-ground between a dirt road and the calf pad (see blue line on the left image). Stream flow travels north through a culvert under the barn.

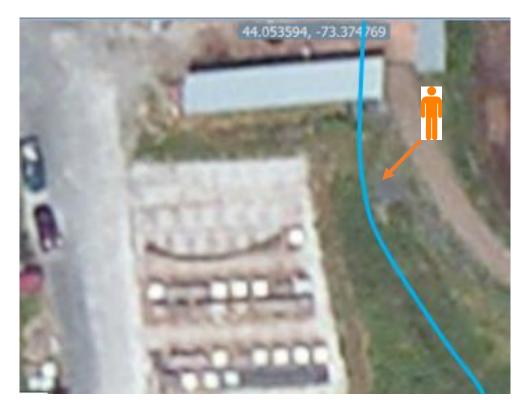
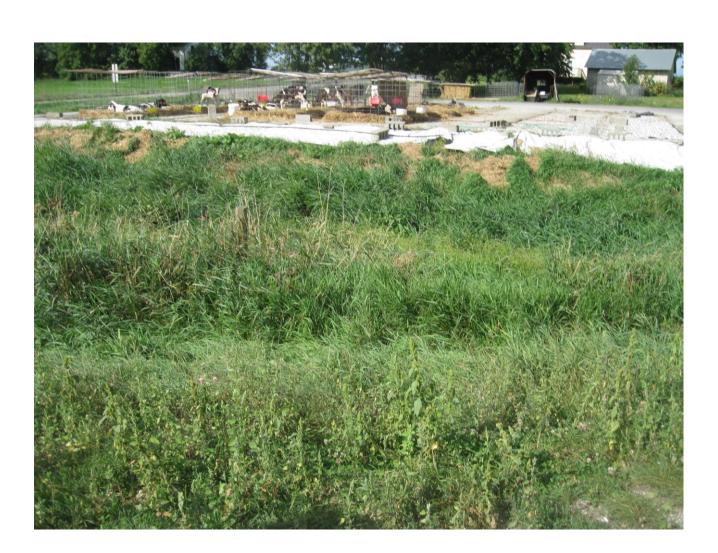
Bonaspecta Holsteins Addison, VT 9-1-17

The inspectors did not see moving or standing water in the area of the stream, but the topography and lush vegetation indicated flow.

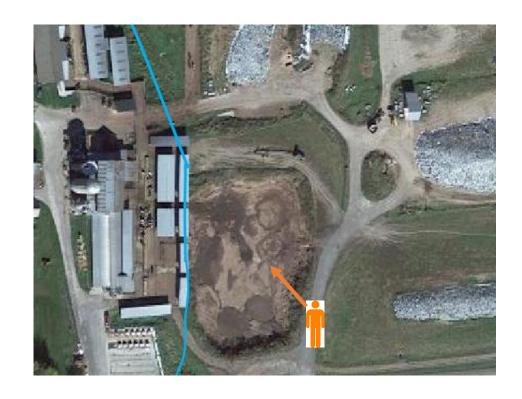
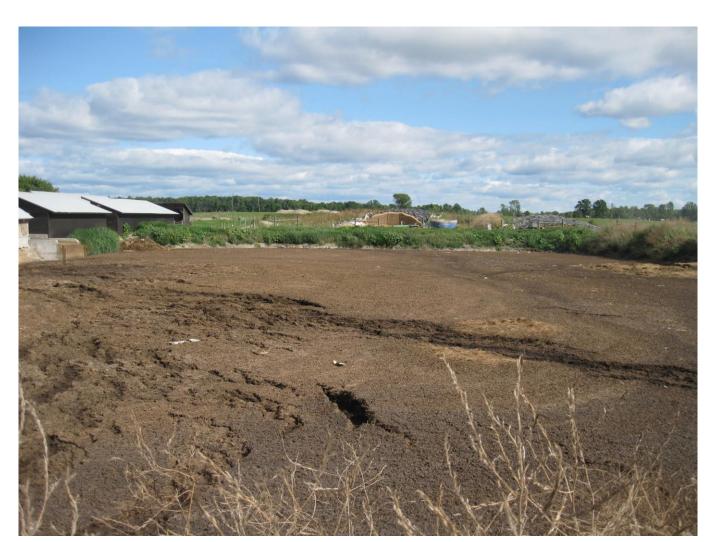
Bonaspecta Holsteins Addison, VT 9-1-17

The farm has a single manure lagoon, which had only a few feet of freeboard at the time of the inspection.

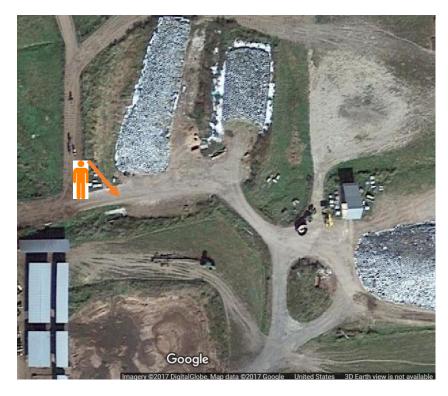
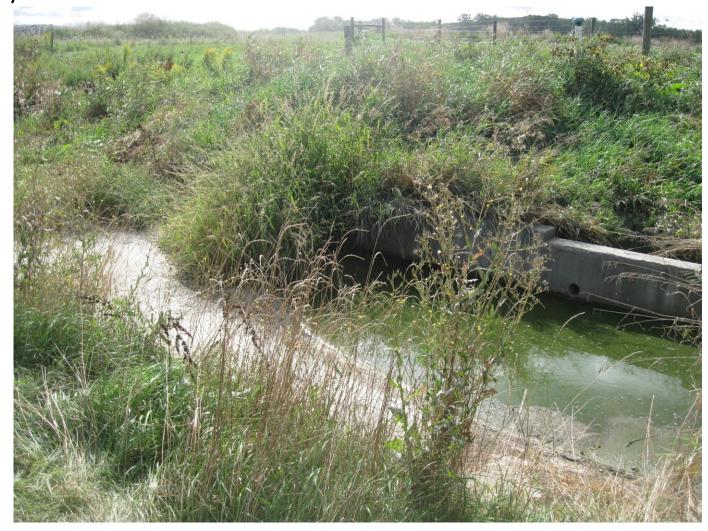
Bonaspecta Holsteins Addison, VT 9-1-17

The farm has a silage leachate system designed to send concentrated flow to the lagoon and dilute (high) flow to a treatment pond and constructed wetland control system.

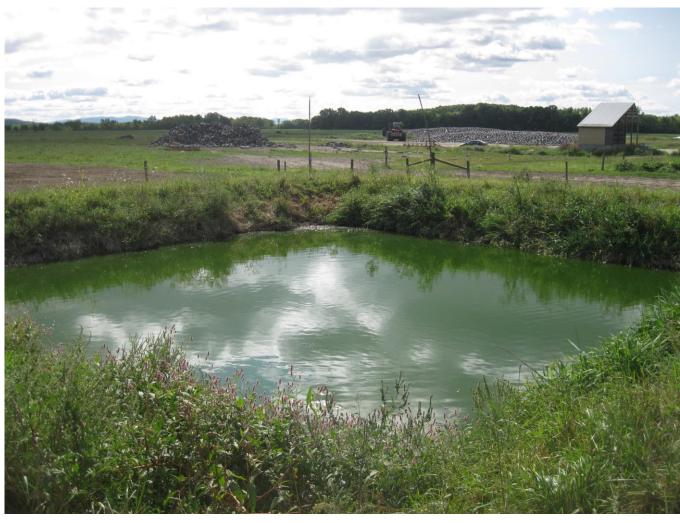
Bonaspecta Holsteins Addison, VT 9-1-17

The silage leachate system diverts low (concentrated) flow to the lagoon and high flow (during rain) to the pond and vegetated area.

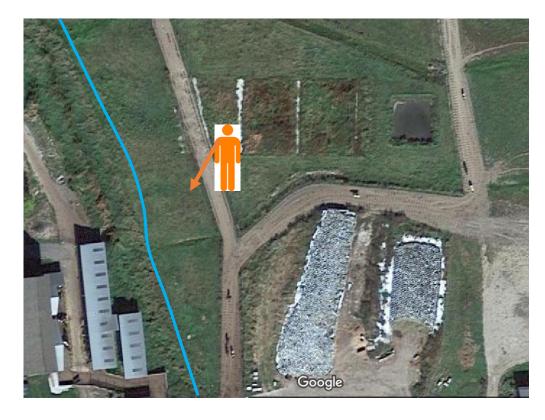
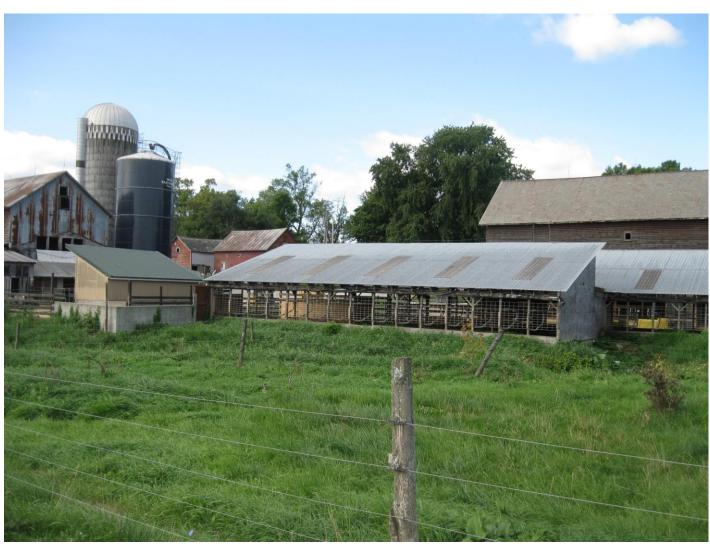
Bonaspecta Holsteins Addison, VT 9-1-17

The unnamed stream, after passing under the barns, runs above-ground north of the barns. Electric wire keeps cows from getting near the stream area.

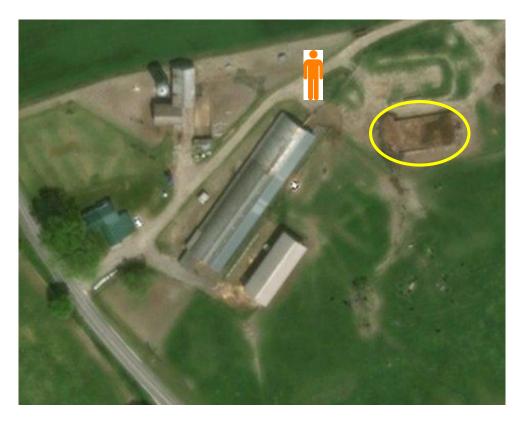
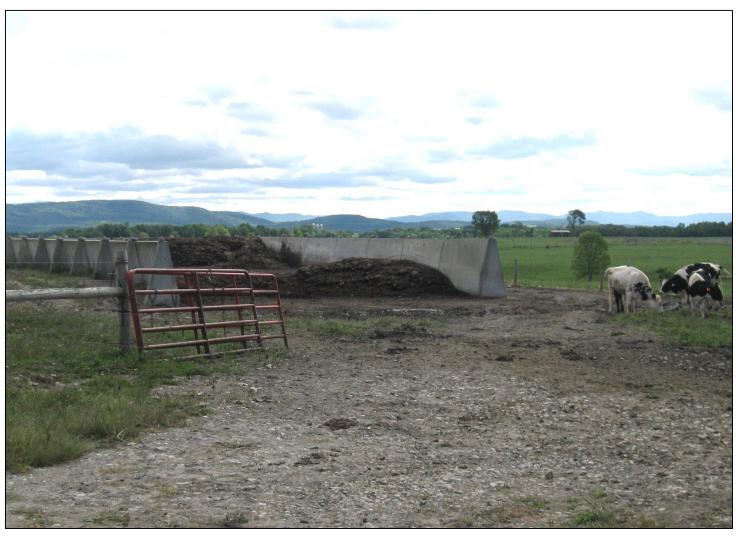
Bonaspecta Holsteins Addison, VT 9-1-17

## The farm stores extra dry manure in bunks at the Heifer Farm

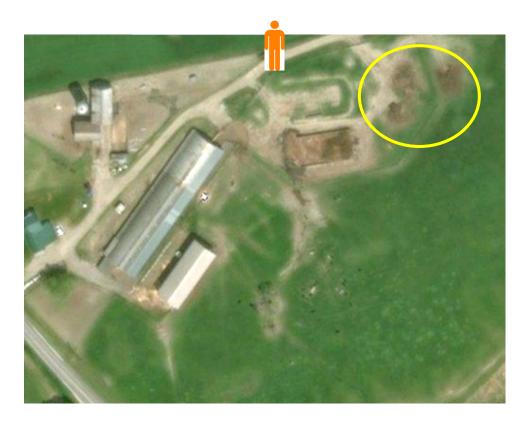
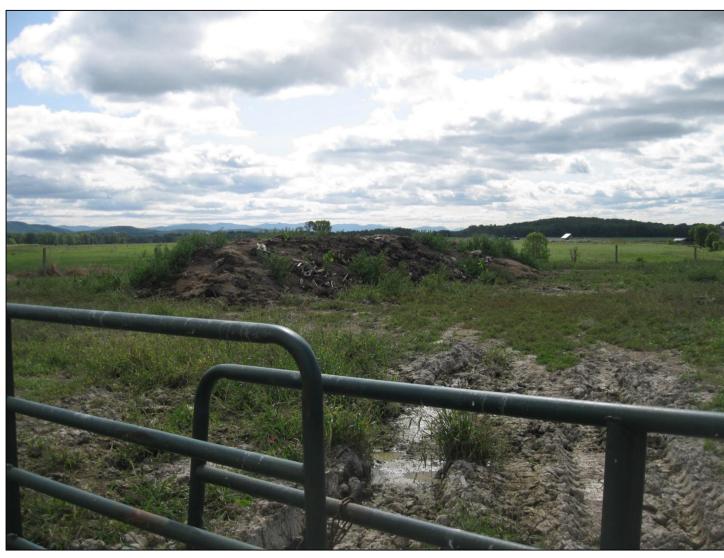
Bonaspecta Holsteins Addison, VT 9-1-17

## The farm stores mortalities at the Heifer Farm

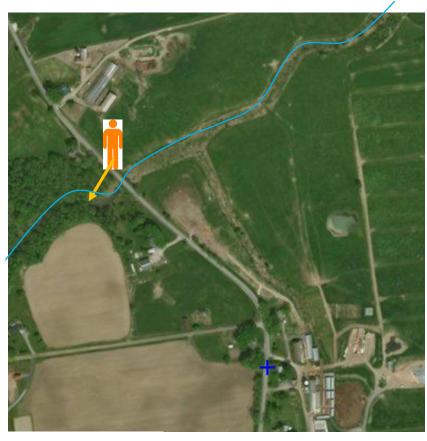
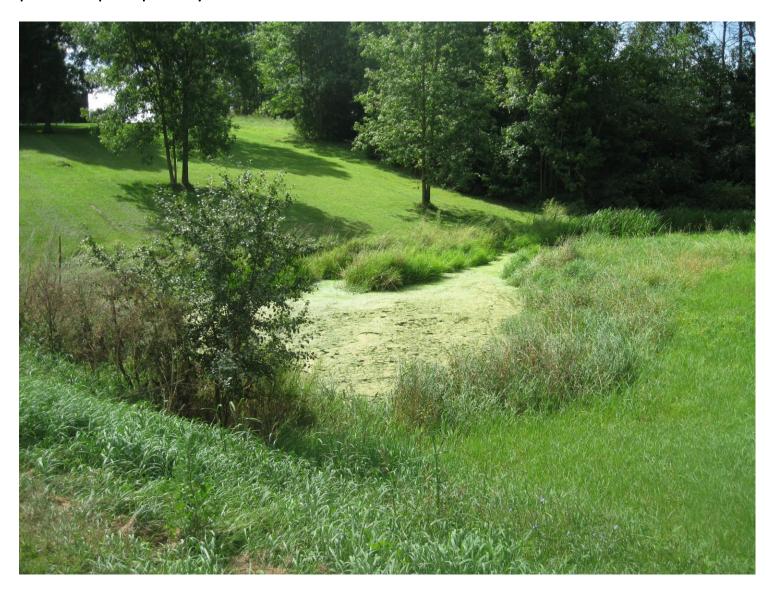
Bonaspecta Holsteins Addison, VT 9-1-17

## Hospital Brook as it leaves Bonaspecta property.
